JANUARY 2018
WATER EMERGENCY TRANSPORTATION AUTHORITY (WETA)

ALAMEDA MAIN STREET FERRY TERMINAL

FACILITY CONDITION ASSESSMENT

ADDRESS COWI North America, Inc.
1300 Clay St.
7th Floor
Oakland, CA 94612
USA

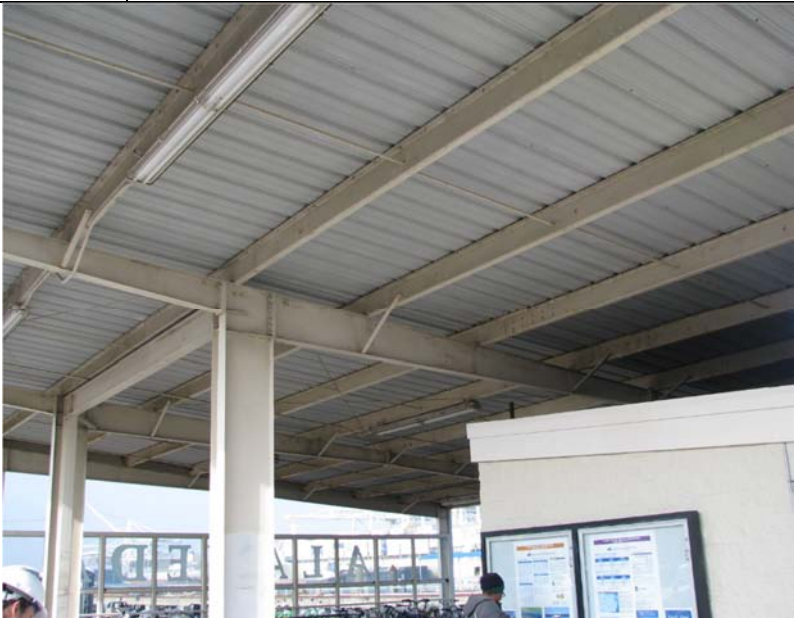
Photo	Rating	Component: Shell
#9398 01-17-2018	4	Description: Passenger Waiting Area Shell

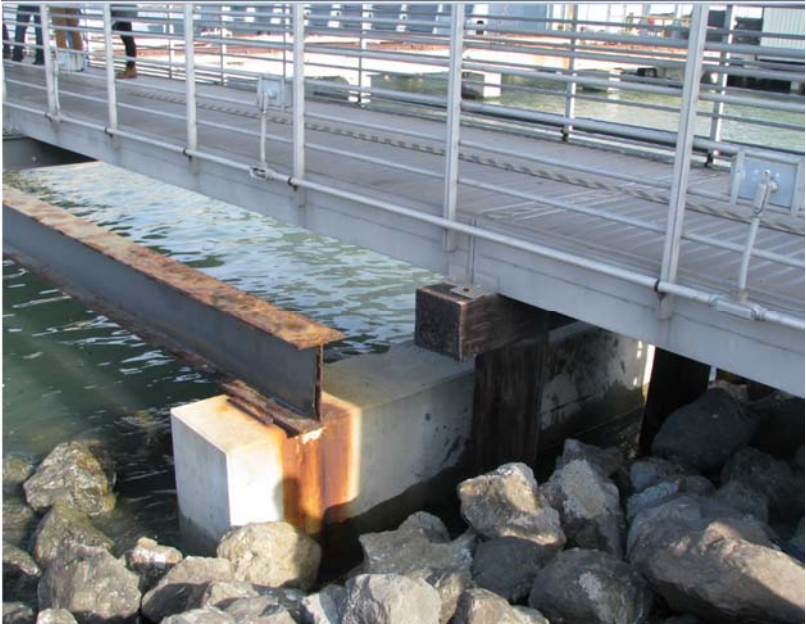
Photo	Rating	Component: Shell
#9397 01-17-2018	3	Description: Bridge Structure

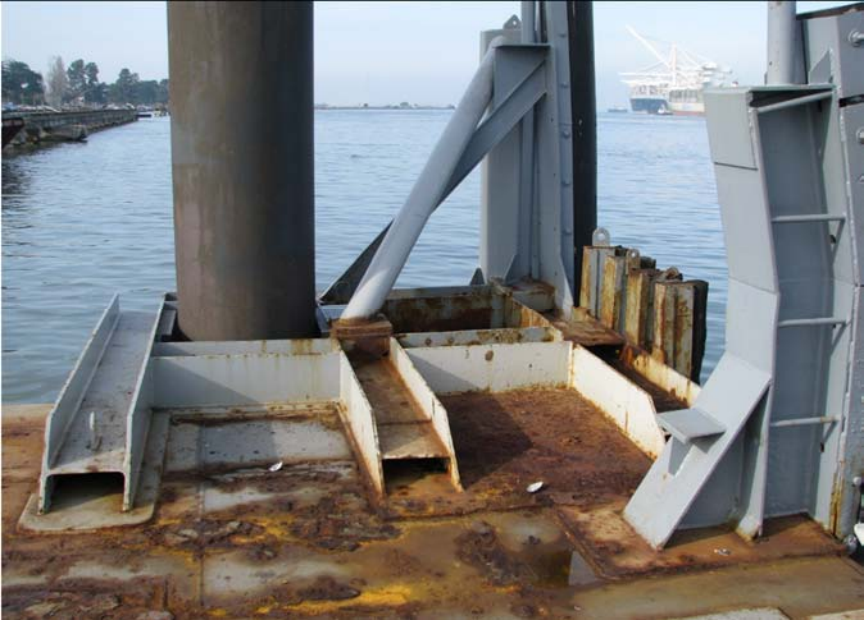
Photo	Rating	Component: Shell
#9373 01-17-2018	2	Description: Float Walking Surface, Pile Collar
